REVEGETATION & WILDLIFE MANAGEMENT CENTER

River Glen Mitigation Project Second Annual Report

Bertin W. Anderson

1 March 2009

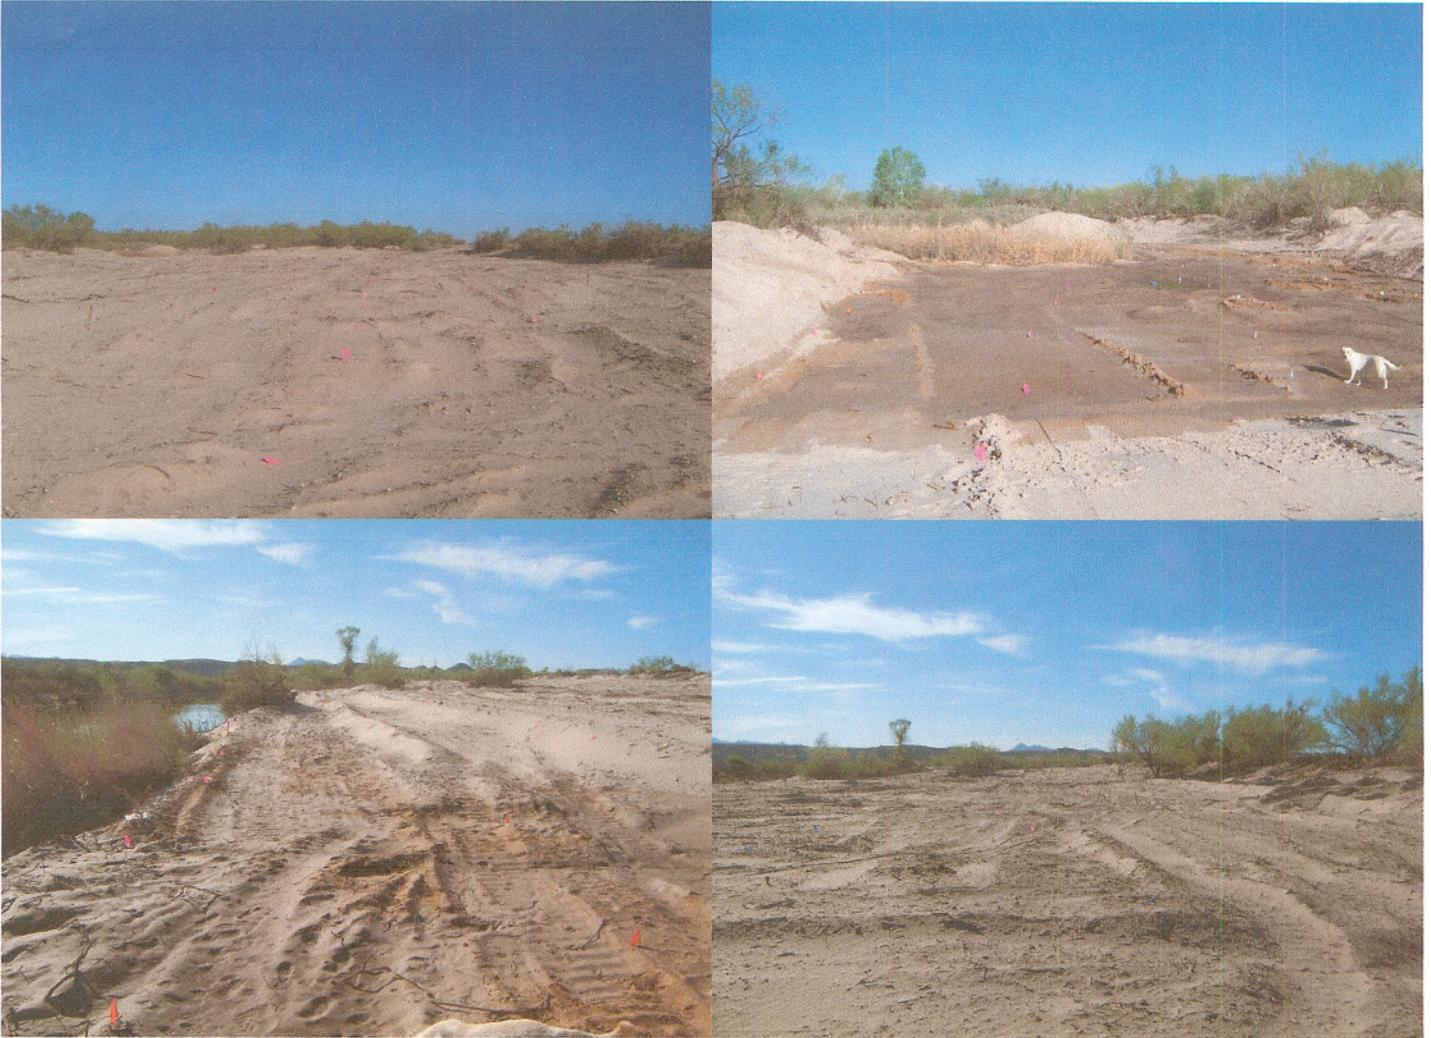
Figure. 2. River Glen revegetation site shortly after clearing in April 2007. Section A on top; Section B, -bottom.

Site preparation ordinarily involves clearing and leveling the area with a D-7 or D-6 Caterpillar dozer (or equivalent) over as much of the area as deemed necessary. This clearing was done (March 2006) in a selective manner, thus extant vegetation deemed valuable to wildlife was saved. This included primarily screwbean.. We emphasize that trees left intact on a site are potentially potent competitors with planted saplings. The total trees left intact does not include any trees on the periphery of the site.

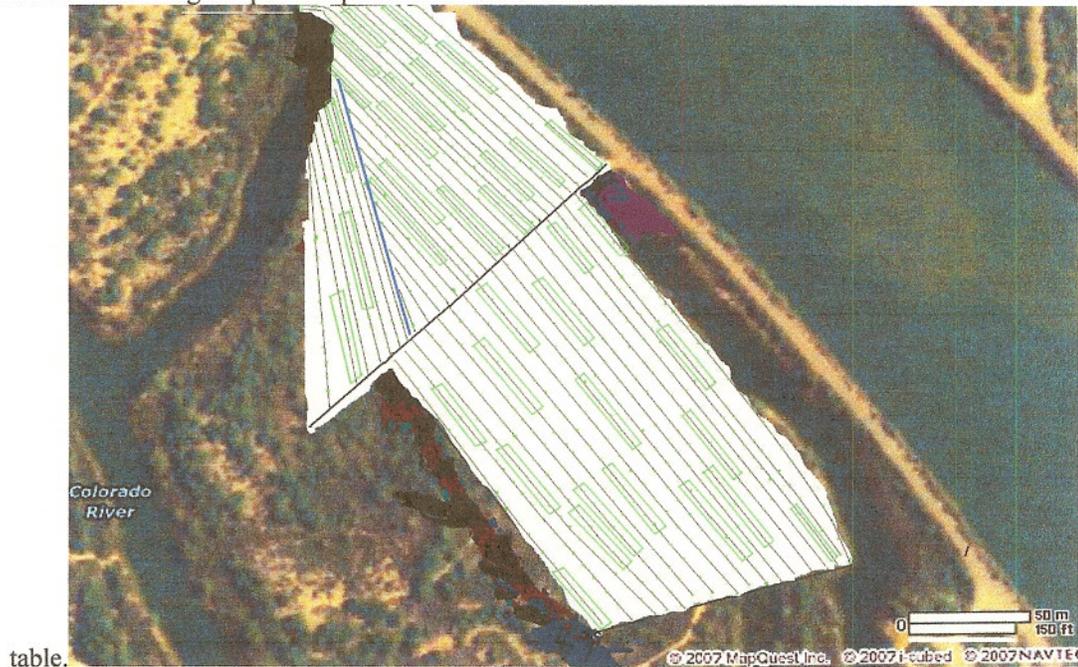
Figure 3. River Glen mitigation project irrigation system design and soil sampling design. The lines with green dots represent lateral irrigation line and tree planting points. In each of the rectangular areas soil samples are collected at 5 points. A each soil sample point one sample was taken from near the surface, the other at about 1.5 m below the surface or just above the water table, whichever was shallowest. The dark line across the site represents the main irrigation delivery line. The blue line in the upper portion of the plot is a berm consisting of cleared vegetation and debris.

Soil samples were collected according to a systematic sampling design Fig. 3. We sampled in sets of 5 points, these sets systematically distributed across the site in a way that gives a reasonably good idea of the distribution of each variable considered across the site. At each of the 5 points where sampling was done a tree was planted. These trees constitute the sample that is monitored—they will be the trees that reflect the progress on the whole site throughout the monitoring period. Since soil moisture varies little over considerable space we assumed that in each series of 5 sample points a soil moisture sample from the mid-point would be sufficient to represent the entire set.

The irrigation system for trees consists of what is commercially referred to as ½ inch black polyethylene drip tubing emanating from black polyethylene main line two inches in diameter. Each lateral drip tube line is supplied with a screen filter and ball shut-off valve. At about every 5-6 m, 7.6 l pressure compensating emitters are installed in the line. Water is ordinarily drawn from existing wells or from the stream channel. Water can also be delivered to drip systems from water trucks. Details of the irrigation system design cannot be made until intensive sampling design is complete. The economy of water associated with drip irrigation is common knowledge. It also keeps weed problems to a minimum and encourages rapid root penetration to the water

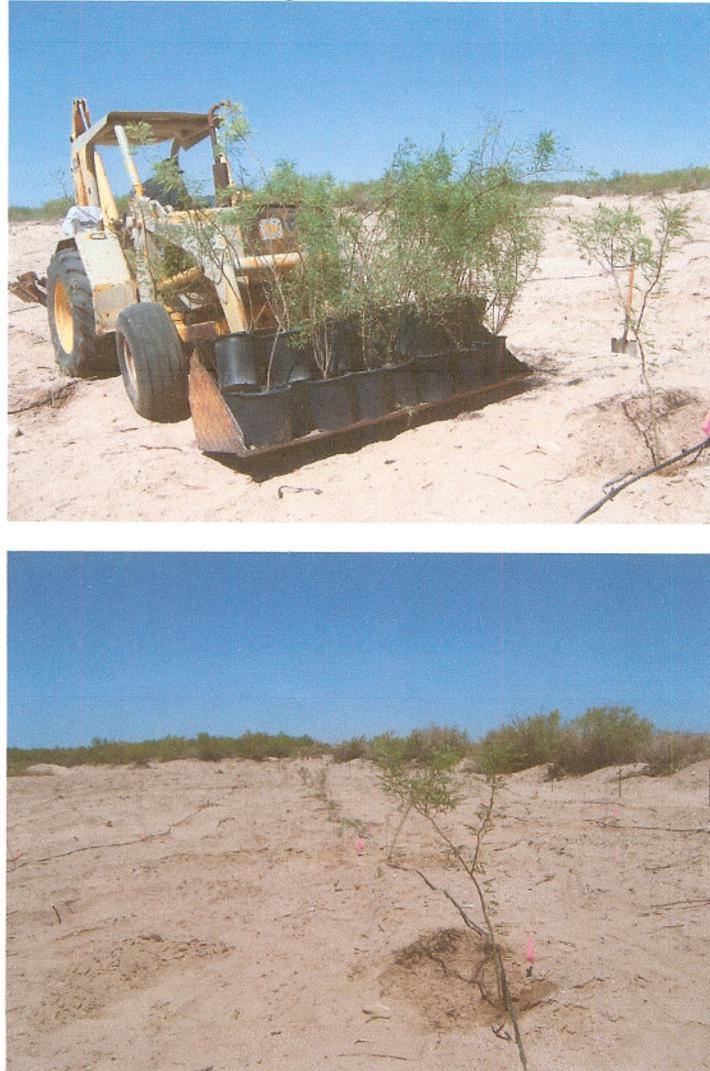
Figure 4. Planting on the River Glen mitigation project.

Trees appropriately distributed on a site are ordinarily planted in densities of roughly 250-338 per ha. This may vary somewhat depending on species and locations. Planting occurred at roughly 300 trees per day between April and July. Planting was delayed as a result of failing to get contracting details completed in time to get the trees started in August 2003. Only cottonwood were ready to be planted in May. The screwbean mesquite were planted as they became sufficiently developed in July 2004. At planting cottonwood propagules were about 38-50 cm tall. Wire fencing was used to protect cottonwood and *Tubex*, a commercially manufactured protective tubing, was used for mesquite that appeared especially vulnerable (those near relatively large patches of vegetation) to rabbits or rodents.. This protective tubing has the added benefits of slowing competitor growth, deterring browsing, and increasing water use efficiency. Chemicals were added to reduce pH and phosphates and nitrates were added to increase growth.

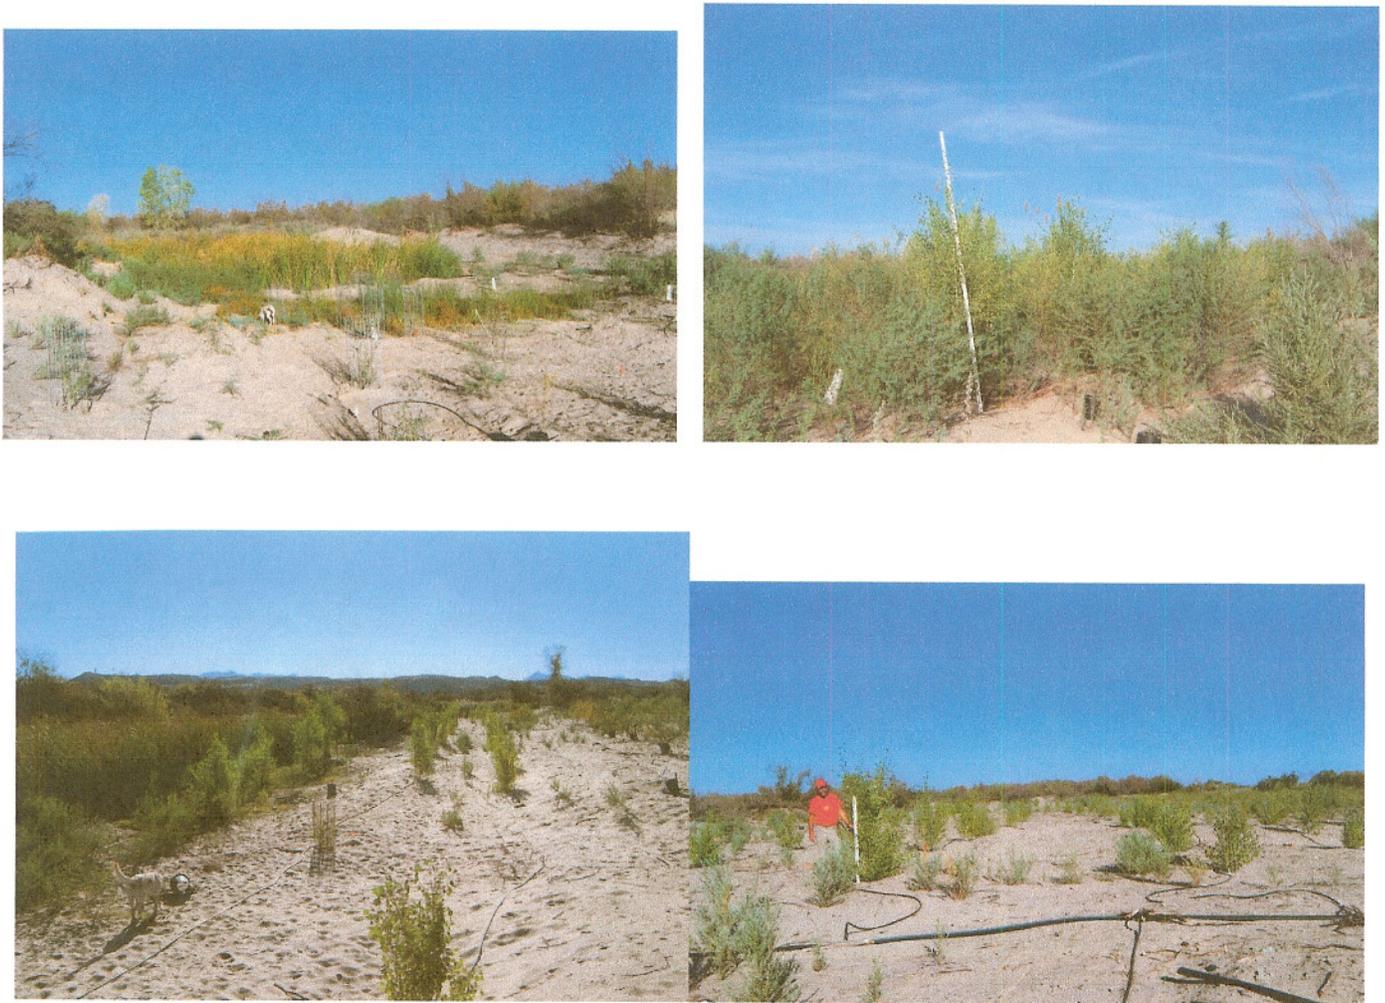
Figure 14. Top photograph, marshy portion at north end of the site 2007 (see Fig. 2, upper left). Same area 2008. Middle, cottonwood on the revegetation site (compare to upper right in Fig. 2). Lower photograph is of cottonwood and screwbean on the north portion of the site (compare to lower left in Fig. 2).

At season's end in 2008 these trees averaged 2.33 m tall with 95% of them falling between 1 and 3.7 m tall. An astonishing 43 (41%) of them had reached the 3 yr goal height of 2.6 m. The 5 year goal height is 3.33 m. Twenty five (24%) of these trees fell in the height class including trees 3.0 to 3.5 m tall. Examples of these trees can be seen in the photograph in the upper right in Fig. 14.

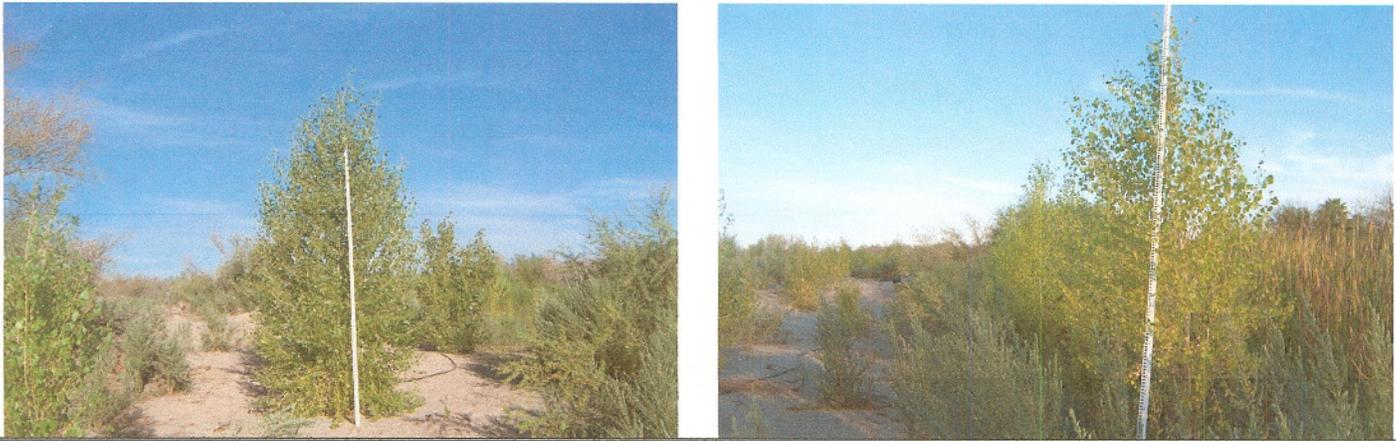
Figure 14. The cottonwood on the left was the tallest tree on the site at the end of the 2008 growing season. This tree had already achieved typical 5 year expectations in just 2 growing seasons. The pole is about 5 m tall. The cottonwood on the right was planted as a one-gallon sapling but it was so close to the water table at the planting point that no irrigation was done for this tree or for 4 others behind it in the photograph.

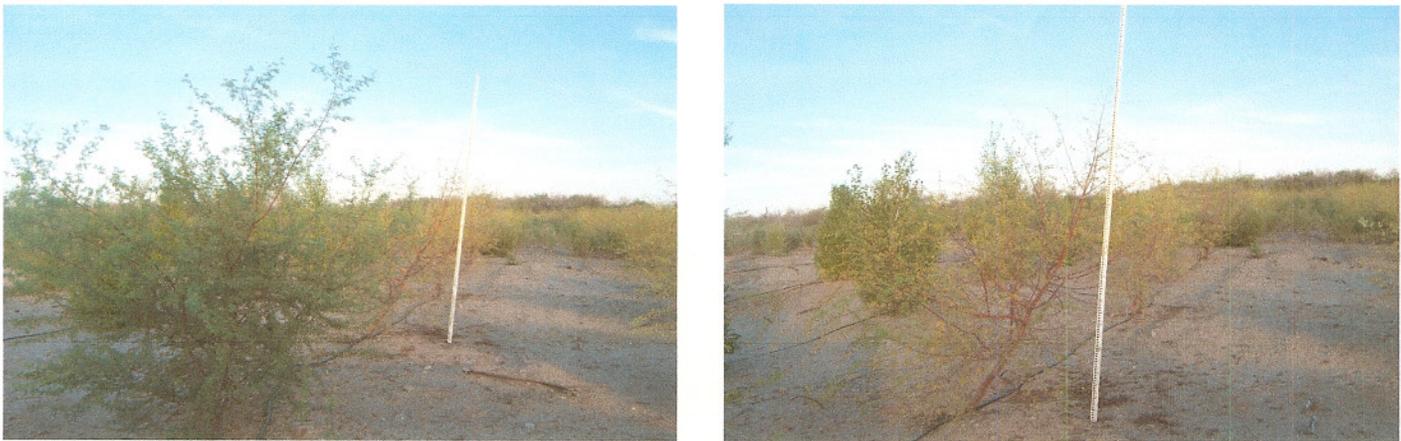
Figure 15. The photograph on the left shows a healthy screwbean in the foreground and a diseased tree behind it. A series of diseased trees are shown on the front. The photographs were taken in October 2008.
